CASE STUDY: White Concrete

Site: Private home, Clifton beach, Tasmania

Flooring: Original slab contained white oxide, burnished and treated with the Kunos white oil in April 2008.

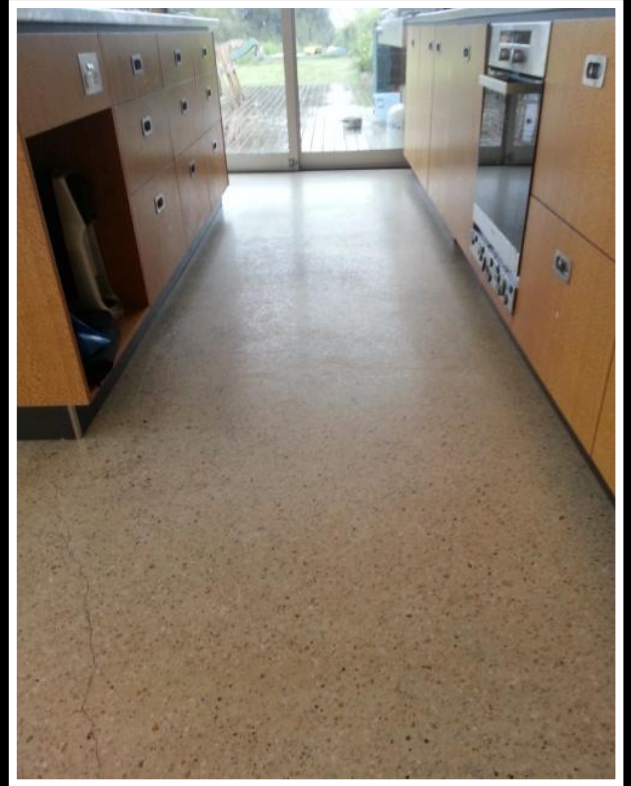
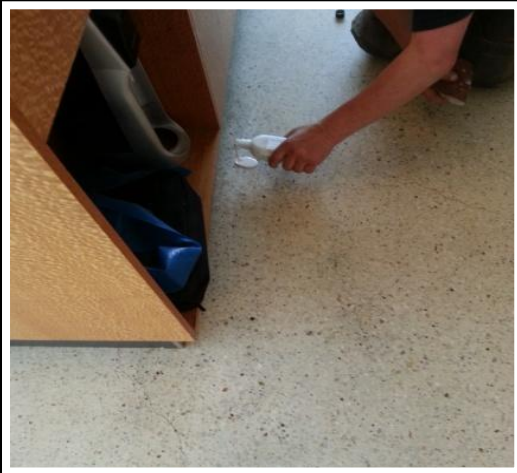
Rejuvenation and Repair: Battery acid had leaked onto the floor penetrating the surface and creating a dull patch.

November 2012, 3 Years since initial oiling.

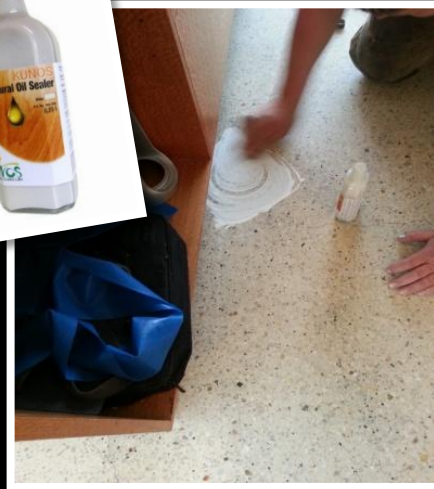
Apply a small amount of the oil originally used directly on the surface, in this case Kunos white

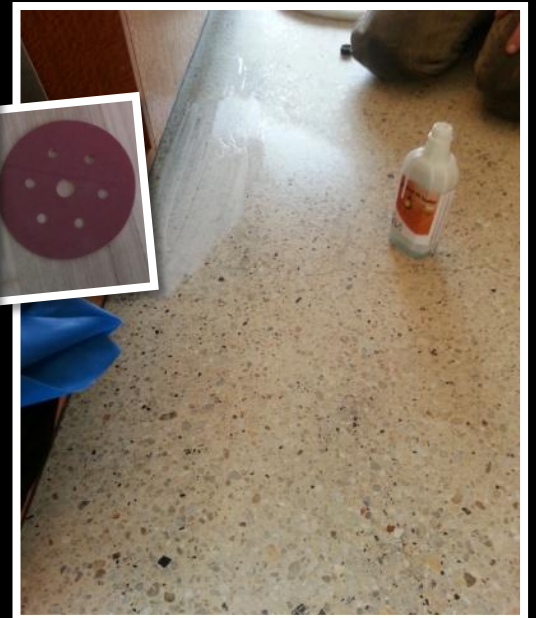
For repairs, work oil in with a fine sand paper over the damaged area

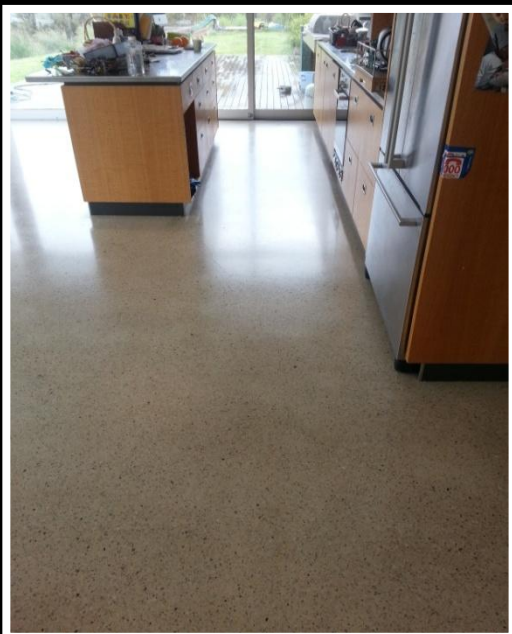
Allow the oil to be absorbed for approx 15 minutes, and then wipe off completely

After repaired and rejuvenated

The whole process required 2.5 hours,

0.5 litres of oil, one orbital disc and one white pad.

Heavy furniture did not need to be removed and the area can be used the next day.
