# Hang On

Teetering precariously on the edge of a cliff overlooking the ocean on the South Coast of NSW, an early 19th century miner's cottage has been given the chance of a second life thanks to its owners' ecological sensibilities and the meticulous attention to detail by Dunn + Hillam Architects, writes Jane Riley.

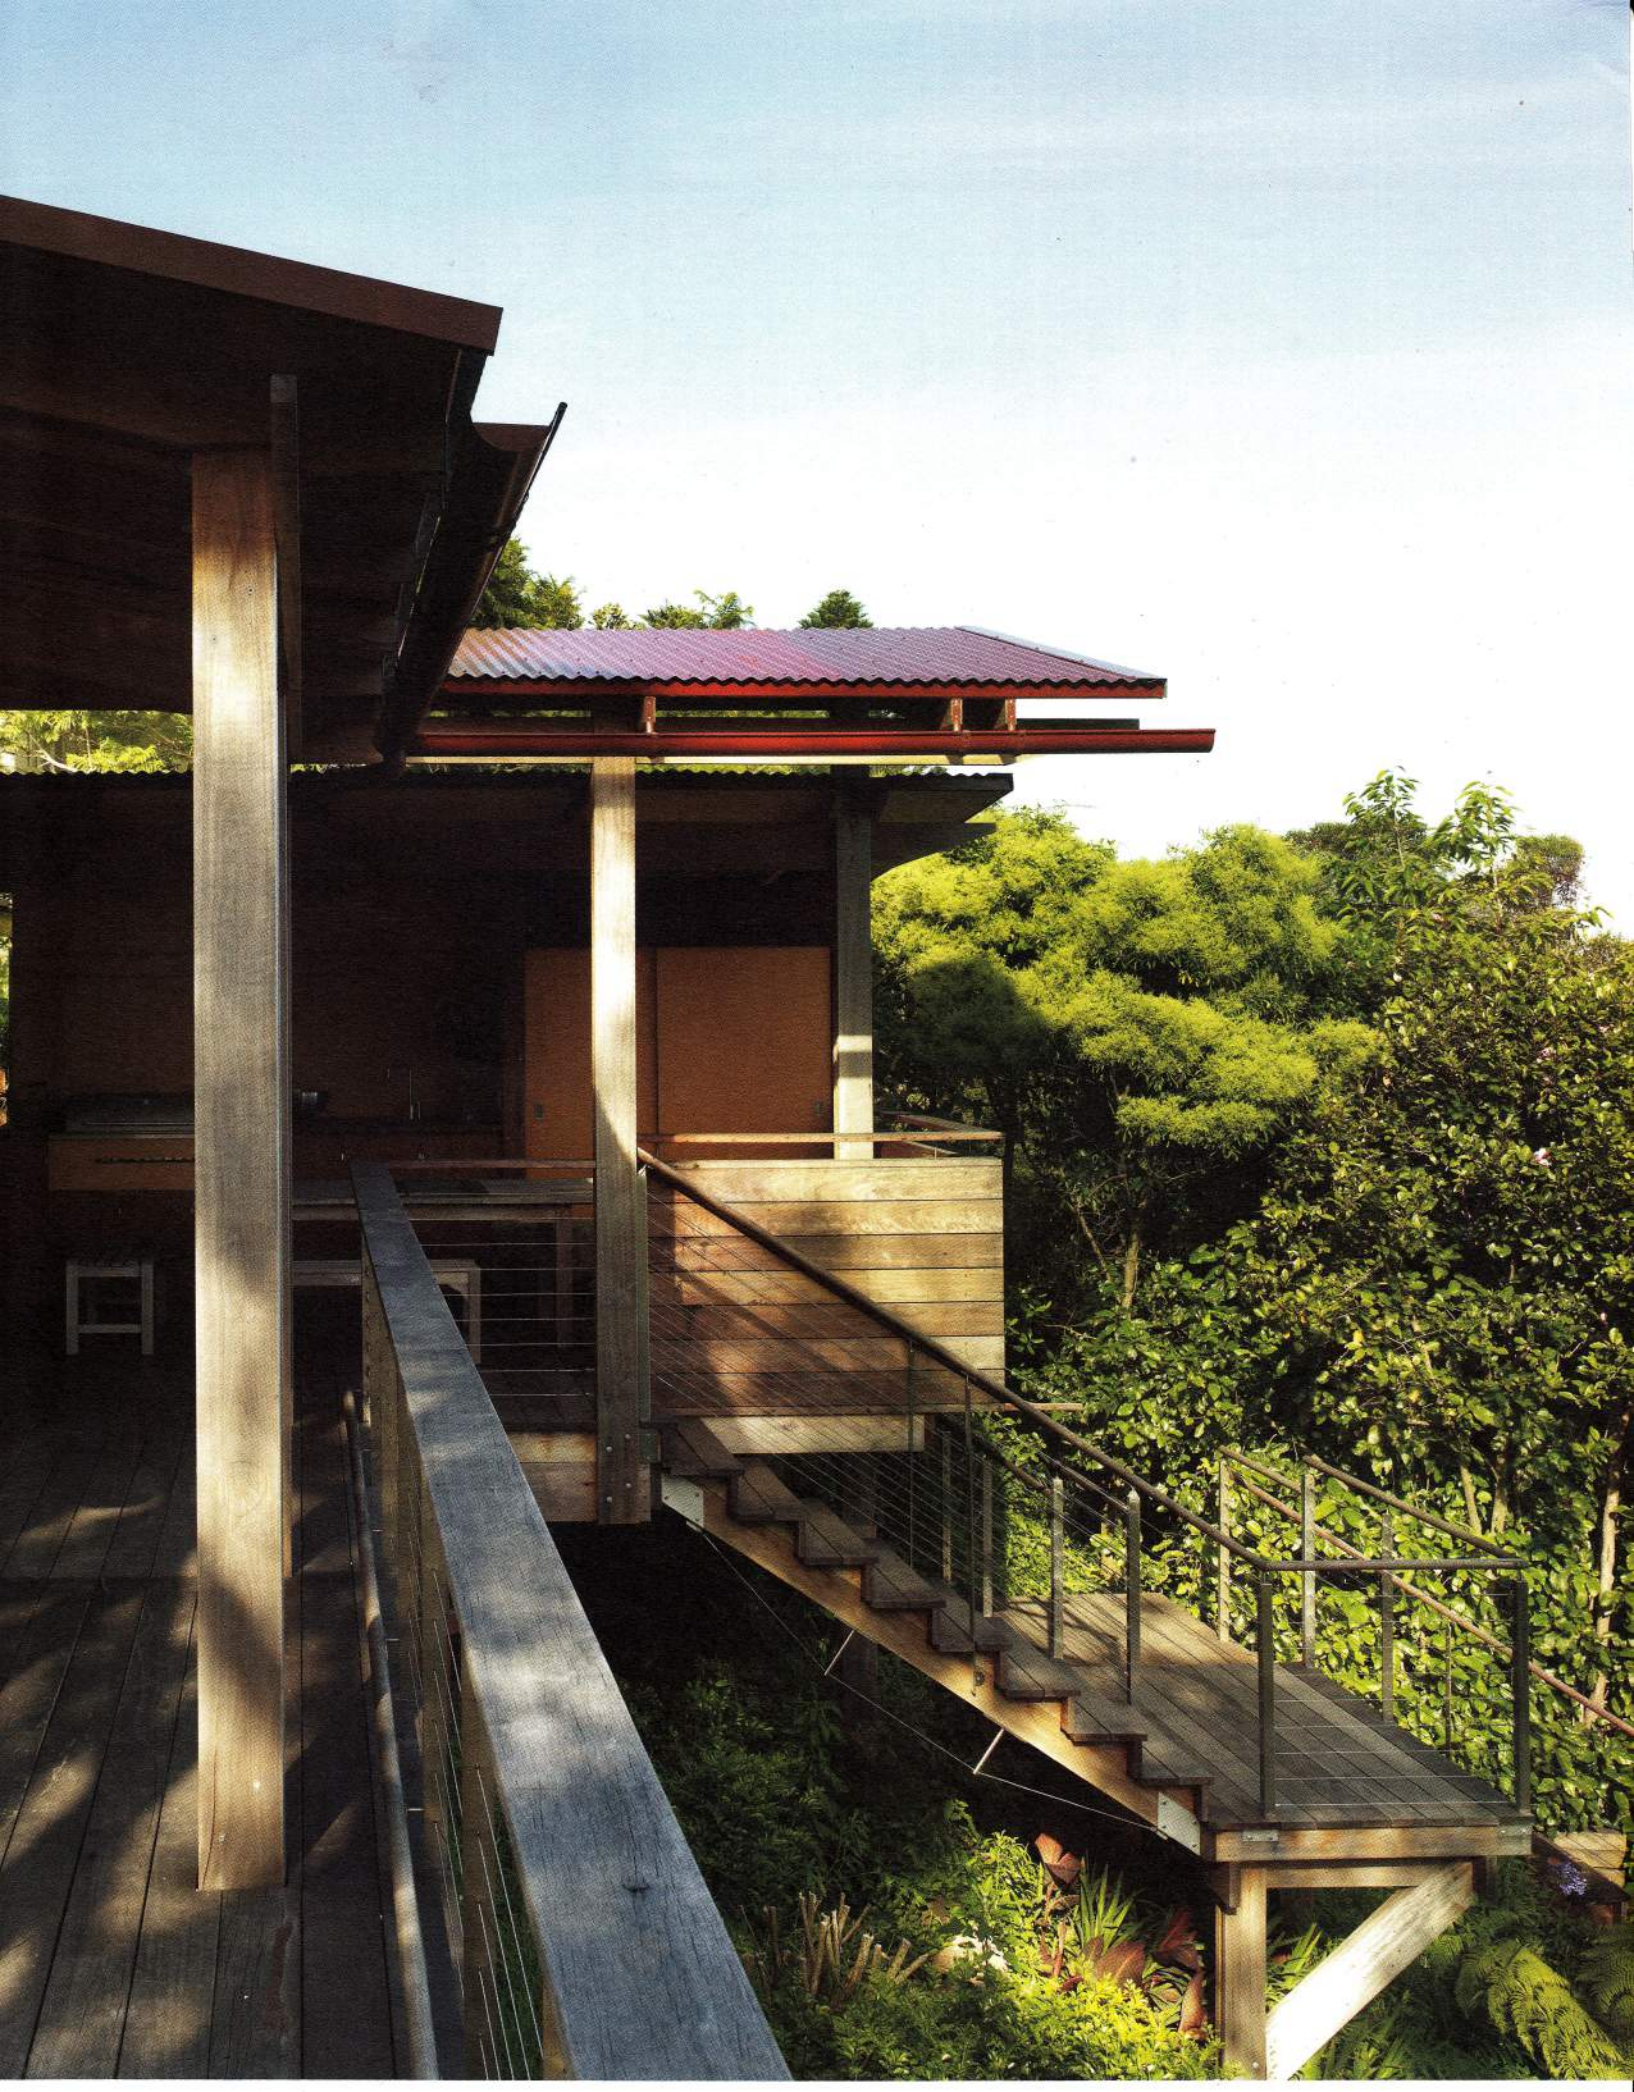
**top** Viewed from the back garden, the cottage looks like a tree house nestled into the bush. **bottom** A vast South Coast national park is one of their neighbours. **opposite page** The original narrow, rotting, soft-wood deck was replaced and extended to increase the living space.

They lifted the deck roofing off the existing roof to encourage airflow and ensure that in summer there is no hot air trapped on the deck; the roof sheeting runs over the top of the rafters and the gutters hang separate, as if floating in the air. Even the timber columns on the deck are split in two so you can see through them.

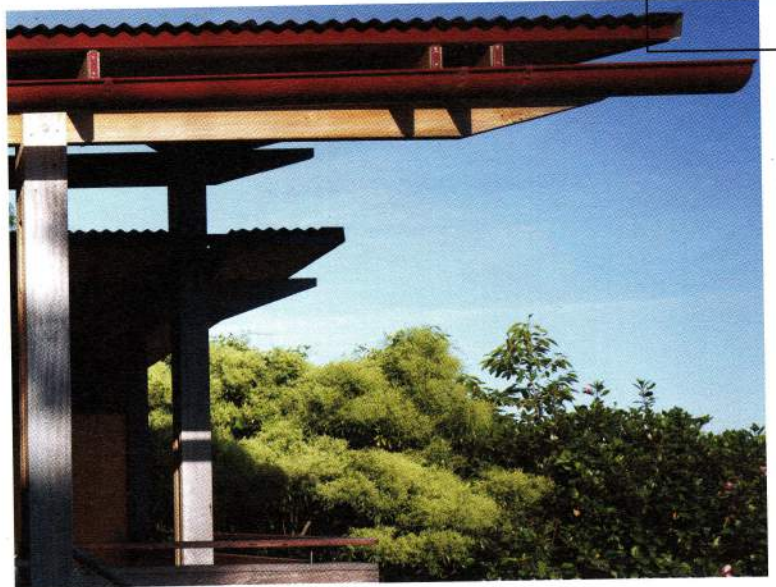
## Floor Plan

| 1/ entry | 6/ kitchen | 11/ deck |
| 2/ bedrooms | 7/ pantry | 12/ storage |
| 3/ bathroom | 8/ outdoor dining | 13/ japanese bath |
| 4/ living room | 9/ BBQ | 14/ fireplace |
| 5/ music room | 10/ laundry | 15/ veggie garden |

The main shape and size of the four-bedroom, two-bathroom, 160-square-metre house was not altered at all. Instead, they made the girls’ bedroom a little larger and included built-ins; moved the laundry to the deck; replaced and extended the verandah; added an outdoor stainless steel bath; included a wood-burning fireplace in the living space to heat the whole house with a cleverly designed music nook behind it.
